A NEW WAY TO MAKE GEL COAT REPAIRS USING PRESTEC 27X1

GLENN CAMPBELL

CAMPBELL COMPOSITES AND CONSULTING

CANZ CONFERENCE OCTOBER 2019

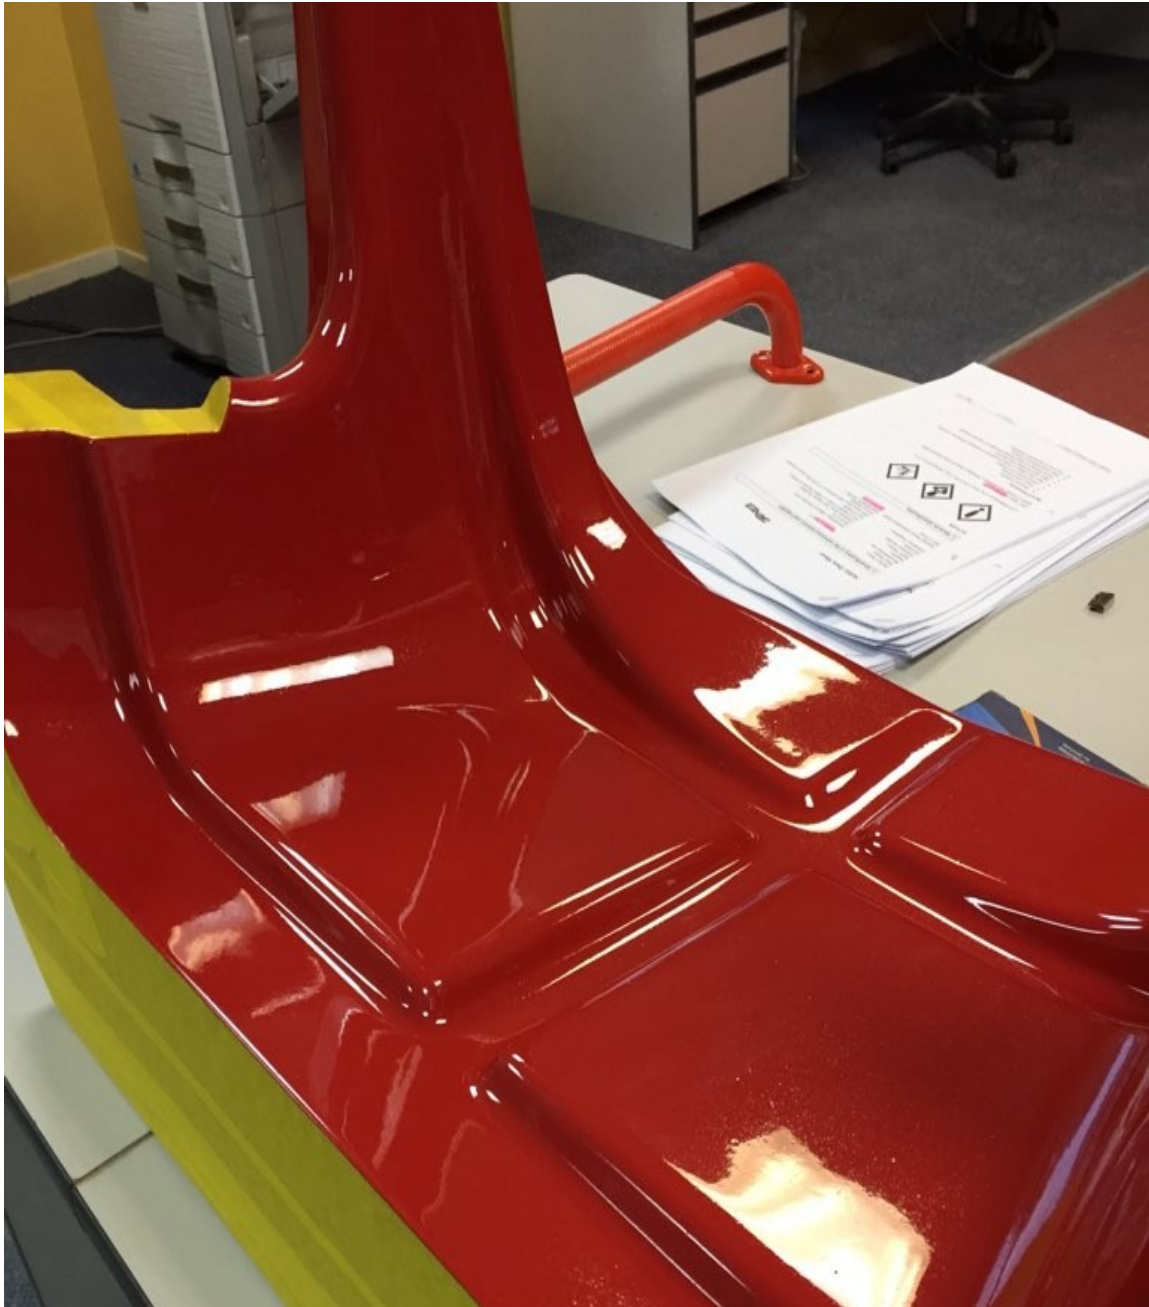
Overlay on
tooling gel coat to
refurbish poor
mpuld surface.

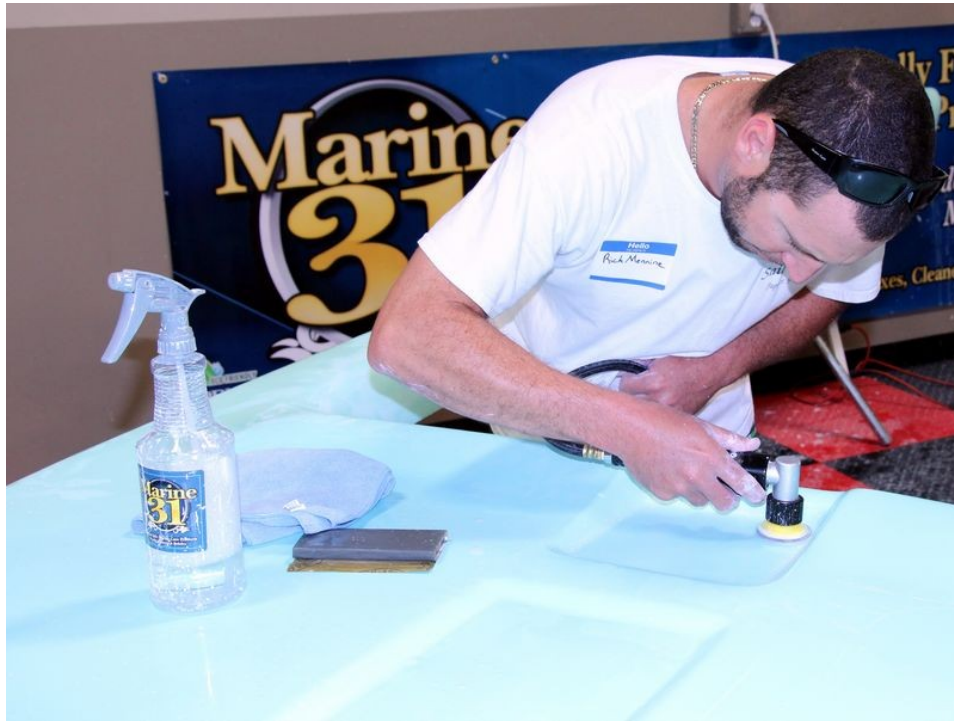
The exposed raw laminating resin is very hard slick in comparison to flowcoats and gelcoats which may contain fillers and pigments making them easier to sand.

Cracking or crazing usually comes from excessive flexing of the gelcoat surface and may require further structural reinforcement to reduce this movement.

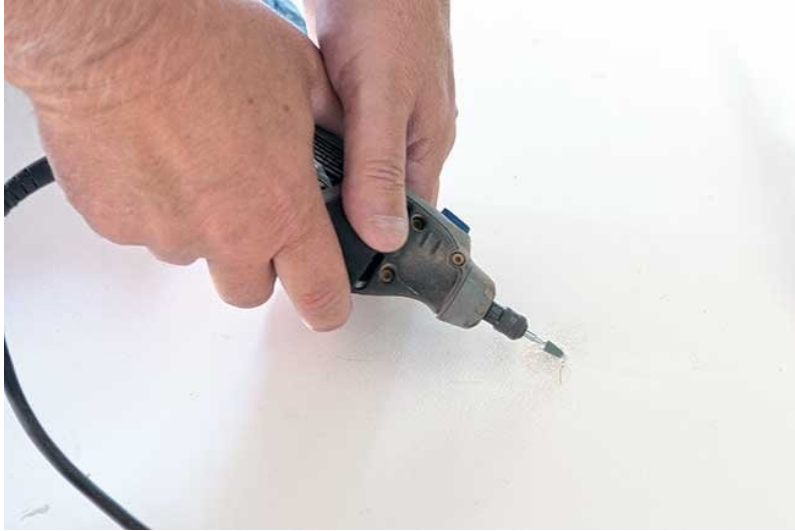
If necessary fill any scratches, pin holes gouges or dents with an appropriate filler (not an epoxy filler) before proceeding. Typically a VE putty. Any cracks open them up a little to give the repair the best chance of seamlessly blending into the existing gelcoat. If you start cutting into the laminates, you're going too deep.

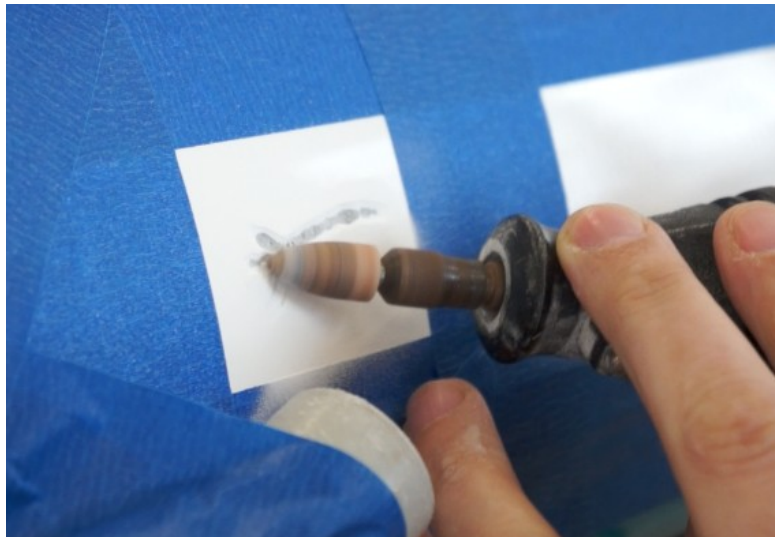
The gel coat being repaired, the surface should be sanded with 80 - 120 grit paper making sure that the edges gel coat being repaired is feathered.

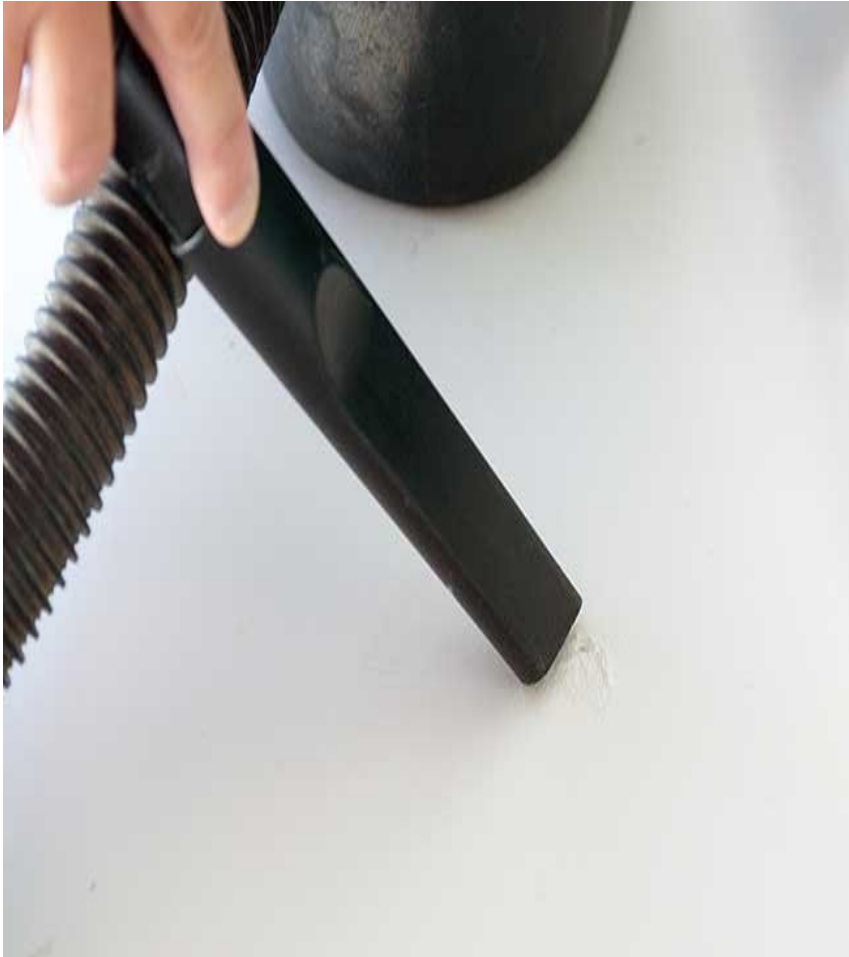
It takes little time if you use the correct equipment and it is essential that this V-shaped groove in the gelcoat is vacuumed to pick up the dust. If you cannot vacuum, blow off the surface with clean, dry compressed air.

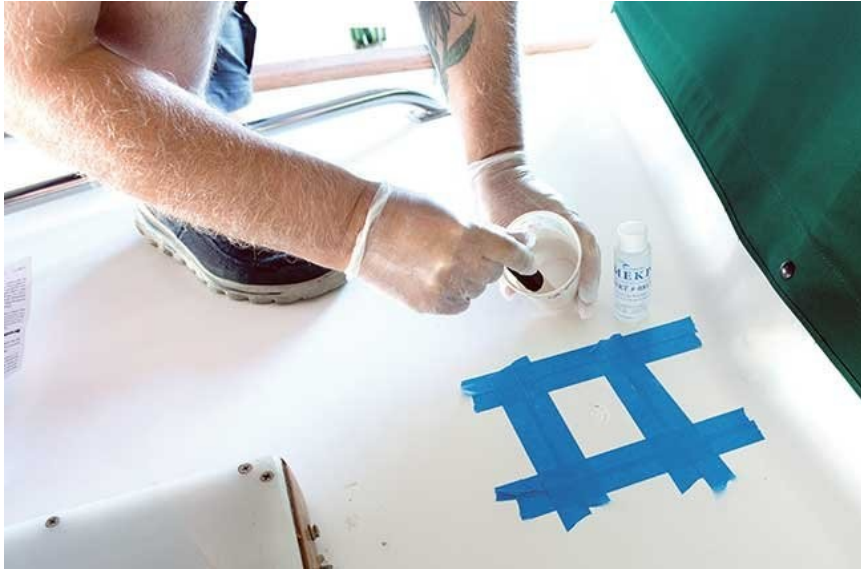
Mix the gelcoat thoroughly following the manufacturer's recommendations. Adding too much catalyst gives insufficient working time; too little, and the gelcoat won't properly cure.

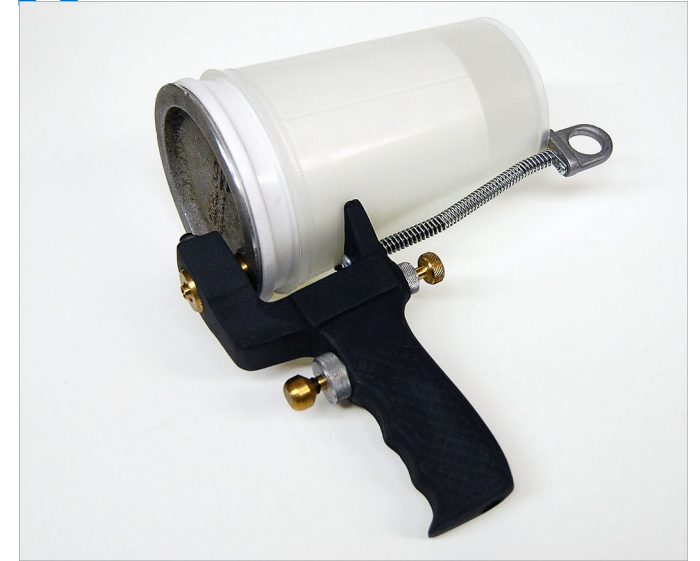
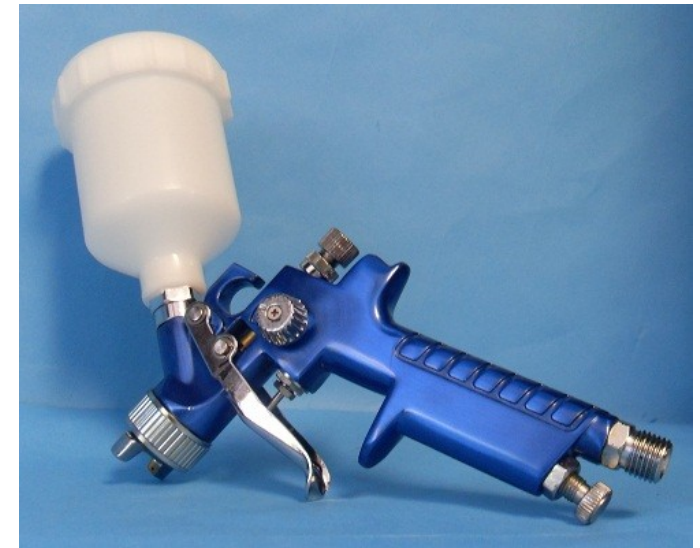
Apply the Prestec modified gel coat (see slide 12), preferably in three passes by spray, to a minimum thickness of 18-24 thou (450 – 600 microns, depending on the colour).

Allow a short period of time between passes so the gel coat laid down in the previous pass has time to set up. Too high a build too soon will cause the gel coat to run.

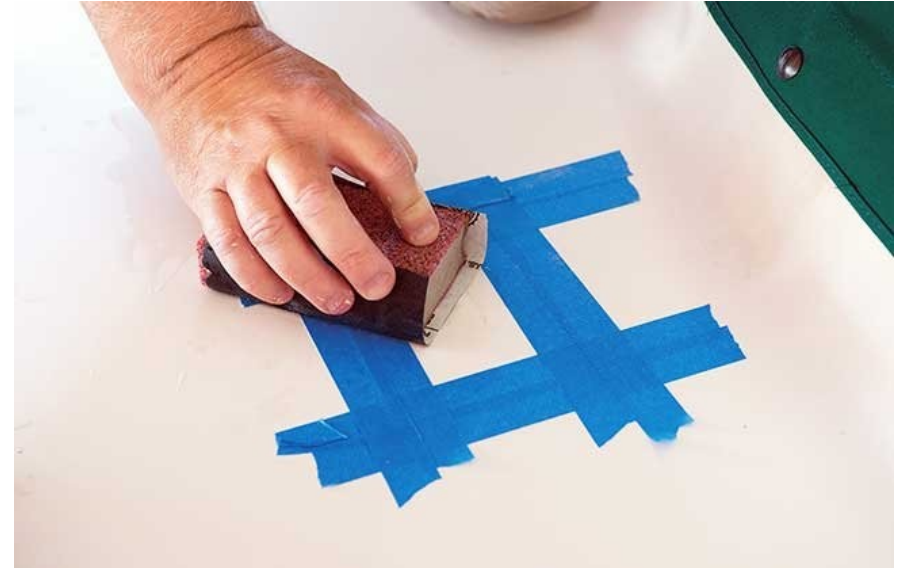
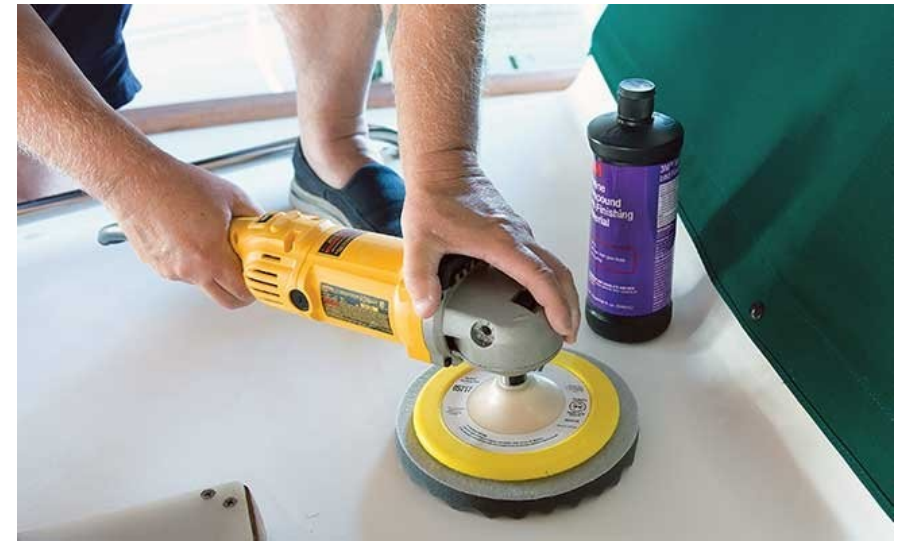
Cut and Buff the cured gel coat repair after a minimum of 24 hours, ensuring the gel coat has cured sufficiently. The repair will be temperature dependant at the time, so any method of assisting the cure using heat (like a hair dryer) will be the best method. Any assistance with heat should be done after the gel coat has passed its gel time. Now you can begin to sand down the repair until it's flush with the surrounding surface. Start with 180-grit waterproof paper wrapped around a block until flat and smooth. Then switch to 240-grit before finishing off with 400-grit or finer, which removes any scratches.

Remove the masking tape and plastic sheet, then finish off the repair with cutting compound followed by a layer of wax polish. You can hand-buff, but a slow-speed buffer leaves a better finish.
